Inspection Report

Minerals Regulatory Program

Mine Name: Kimball Draw
Operator Name: U. S. Gypsum

Permit number: S0150075
Inspection Date: July 29, 2008
Time: 2:00-2:20 PM

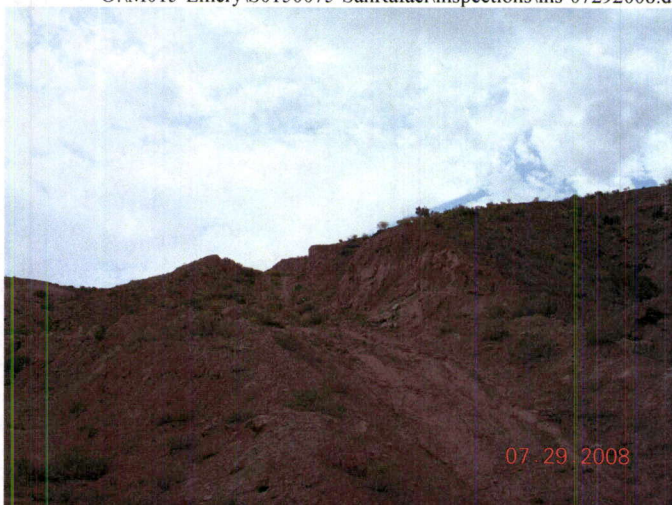
There is a berm on the road outslope that should be pulled back on to the road. On the inside of the road is a cut, and we decided the top of the cut should be smoothed so it blends better with the surrounding area. Totally regrading the road is not desirable or necessary and would destroy vegetation that has established over several years.

Photo 1. The berm on the left side of the road should be pulled up, and the bank on the right side should be rounded to make it blend better with the surrounding area.

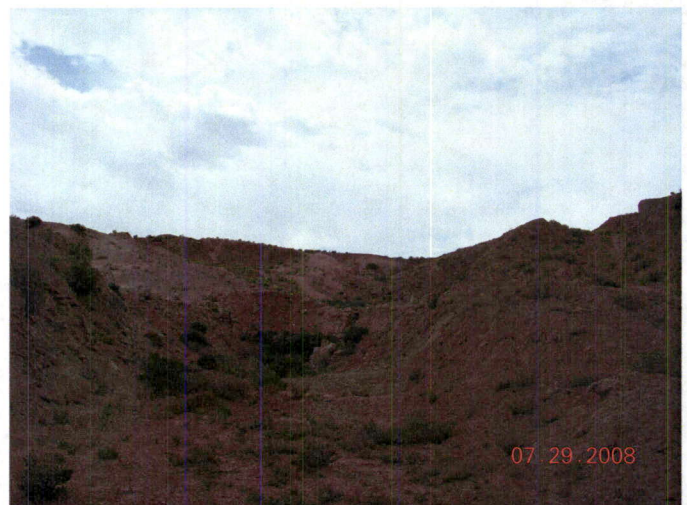
There are some cuts in a draw next to the road, and these need to be smoothed over. As with the road, the operator needs to avoid re-disturbance as much as possible.

Photo 2. This is a cut in the draw next to the road. The top should be smoothed over while disturbing as little of the vegetation as possible.
